# DOVEDALE HOUSE

## Historic Preservation Plan

Darlington County, South Carolina

May 7, 2012 • Final Report  
New South Associates Technical Report 4091

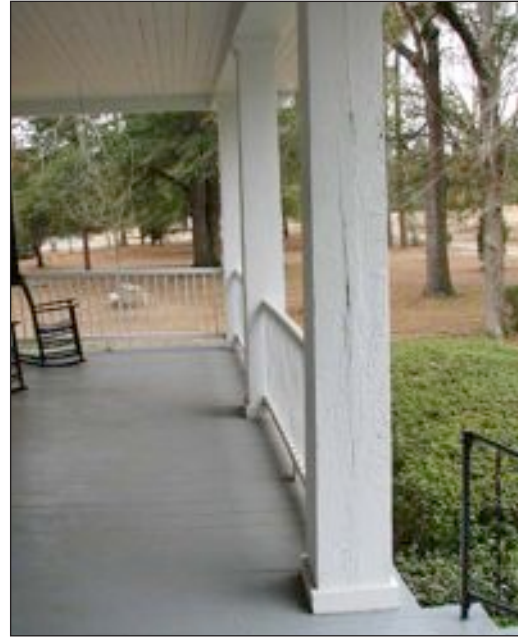
C. Porch Supports and Slightly Sloping Floor, View Southwest

porch floors do not have a long life span. However, proper maintenance of the porch floor would include regular cleaning and repainting to prevent moisture infiltration. Figures 3C and 3D display a portion of the porch floor. While the porch flooring here appears to be in fine shape at this time, it should be monitored carefully, as regular wear can occur at a higher rate on exterior, exposed flooring. The porch support posts have been scraped and repainted, and should remain painted.

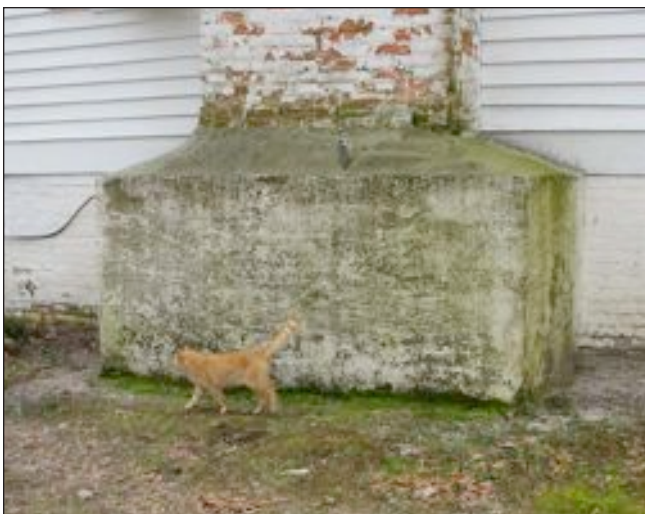
C. Replacement Chimney Base

The chimneys are other facets of the exterior that would need alteration in the pursuit of restoration. Concrete has been added to replace a crumbled chimney base on the north side, a repair that occurred after a tree felled part of the chimney. The brick chimneys have also been painted white, an uncommon and likely unoriginal characteristic feature of a home restored to an 1800s appearance. The dormer across the roof would have to be removed for an 1800s appearance, a change that would dramatically alter the available natural light and space of the upstairs bedrooms and hallway. Of course, composition shingle was not available in the 1800s, so a slate or wood shingle roof would be more appropriate for a historic restoration dating to an earlier era. The concrete stairs for the exterior doors and porch would also need to be replaced; wood stairs are most appropriate.

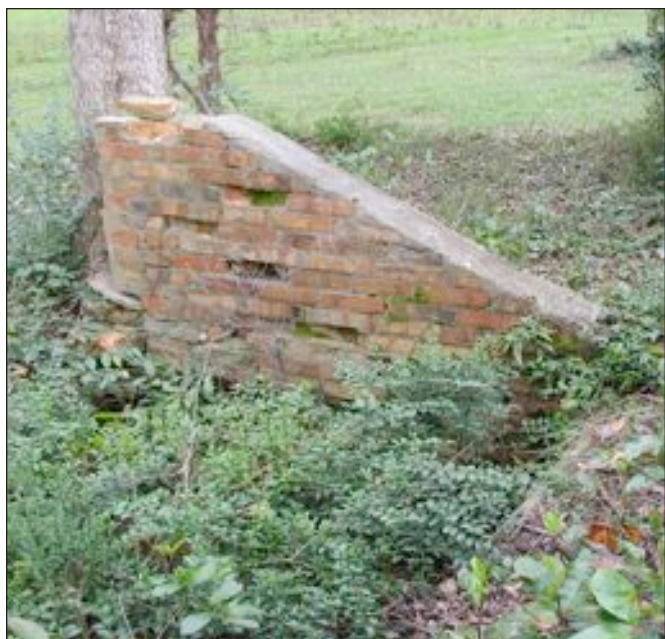
C. Partially Collapsed, Brick-lined Basin, View South

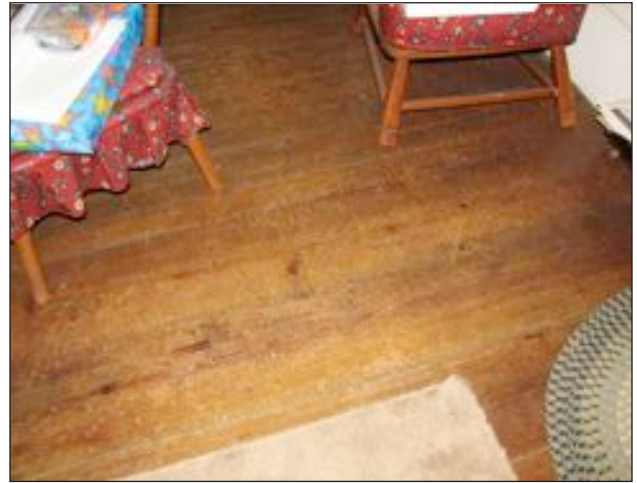
A. Second Story, Wood Flooring at South Bedroom Enclave

around 200 years, even they can show wear (Figure 15A). Maintaining the rugs and carpet runners that are now in place is an excellent way to protect the floors. Areas near exterior doorways need special attention, as these are high foot-traffic areas, and, at this time, rugs often do not cover adjacent floorboards. The floor near the southwest façade side door is a bit worn and is more exposed to the elements, since there is no porch roof above that door (Figure 15B). The flooring here should be maintained by applying some type of wax or preservative on the wood and installing an unobtrusive drip edge atop the doorway to send water off to the sides of the stairs and the door.

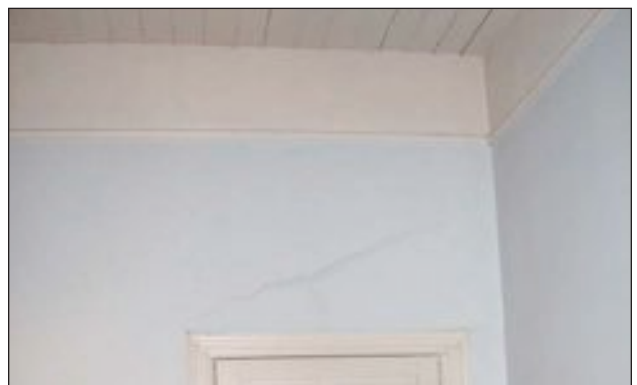
C. Plaster Above Rear Bedroom Door

Plaster walls in the main massing should be regularly monitored for cracking. In the rear bedroom, evidence of cracking is seen above the door to the central hall (Figure 15C). Cracking in plaster is cause for concern unless underlying plaster is in good condition. Using plaster-patching material will easily repair such cracks. For cracks that continue to open with changed in humidity, the crack is first slightly widened using a sharp, pointed tool, and is then filled. Additional information and research materials concerning plaster repair and maintenance are discussed in Chapter V.

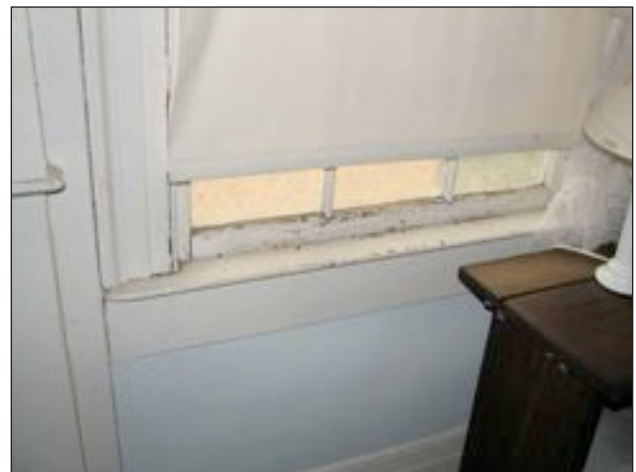
C. Second Window, First Floor Rear Bedroom

flaking, or peeling—can be evidence for excessive moisture contact with window joints and surfaces (Figures 16C-E). In paint failure locations, wood should be examined for its condition as well. Paint failure does not necessarily indicate failure of wood underneath.

Wood soundness can be examined using an awl or ice pick. After jabbing the awl or pick into wetted wood at an angle, a very small section of wood can be pried up. This wood should release in long fibrous splinters if not decayed. If failure has taken place, wood will

Assessments of windows should be made every five years, with attention paid to paint failure, broken glass, loose or open joints, and sill cracking. It is important that when repainting windows, sash should be removed, scraped, repainted, and allowed to dry before returning to place. In order to avoid sticking sash and breaking glass, sash should not be painted shut. Additionally, sealing or weather-stripping of sash will control air infiltration. Installation of interior storm windows in the future would also allow for more efficient heating and cooling. Regular spot assessments and repairs of sash and sills can keep windows in good working order.

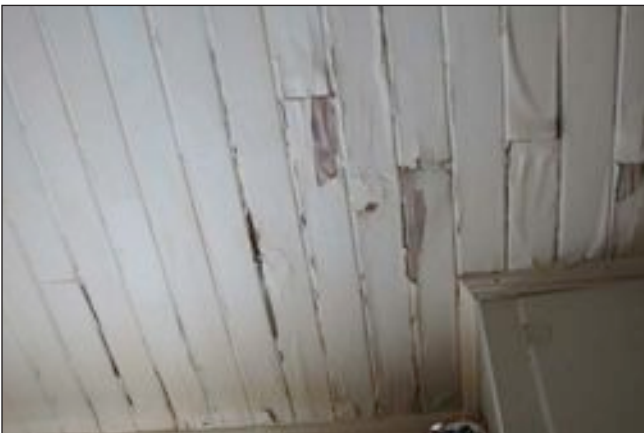
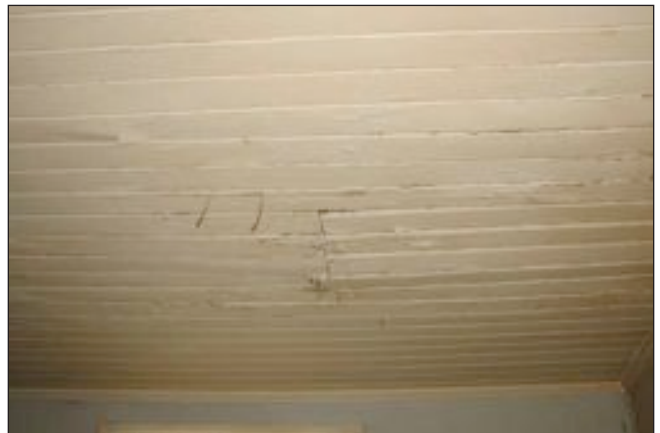
Interior repainting will help retain surfaces within the house as well. On the first floor, evidence of paint cracking is seen in the front bedroom (Figures 17A and 17B). Additionally, blistering and cracking paint in the kitchen ceiling may be an indication that moisture is an issue in this area of the house as well (Figures 17C and 17D). Combining humid, hot weather, lower ceilings, and hot kitchen conditions can lead to paint and wood problems from both interior and exterior conditions. The exact cause of this problem is currently unknown but steps should be taken to examine the ceiling more closely. The paint in this room should be gently removed using careful hand scraping where possible. Once paint is removed, wood should be examined for moisture damage. Where wood failure has been determined, it should be replaced.

C. Kitchen Ceiling, Rear Section

Furthermore, an examination of the rear section of the house's spraddle roof should take place as soon as possible to determine areas of fault. Where necessary, flashing and cracked or broken downspouts should be repaired, and roof shingles should be replaced. The entire roof should be inspected each year. Often, a roof inspection should take place during or just following a rain shower, to allow for utmost visibility in tracking possible moisture and gutter problems. Gutters throughout the house exterior should be cleaned and inspected twice each year. If it is found necessary to replace the roof, use precaution in correcting issues that may cause future moisture problems but be sure to maintain the overall historic spraddle-roof design.
