A QUALITATIVE ANALYSIS OF GRAFFITI INSCRIPTIONS AT ECCLESIASTICAL SITES IN THE SOUTH CAROLINA LOWCOUNTRY

South Carolina Historic Preservation
Conference; APRIL 25, 2025

BY: HANNAH TRUMAN
CLEMSON UNIVERSITY
M.S. HISTORIC PRESERVATION

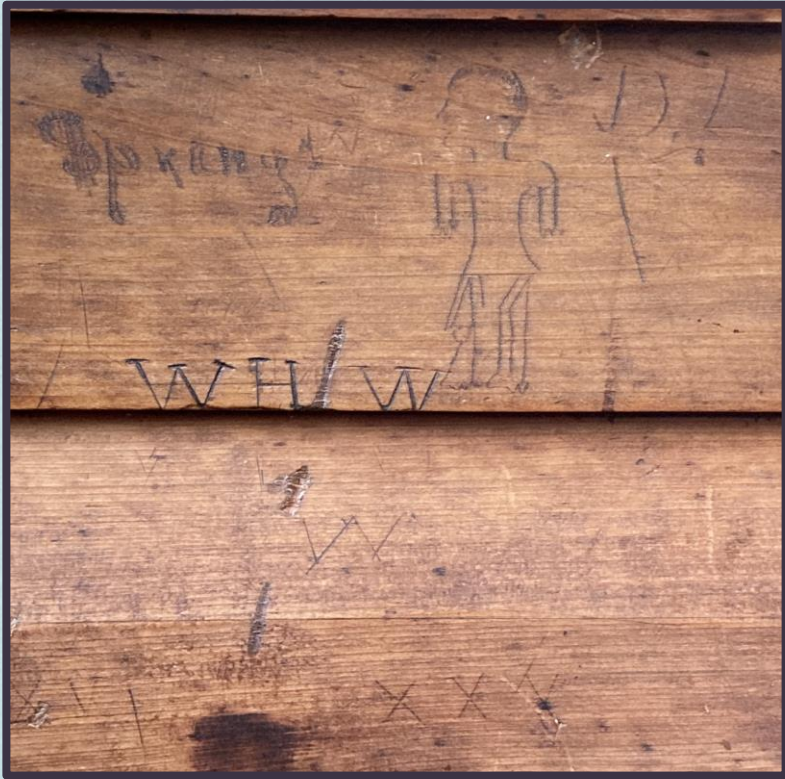
**Inscriptions
of people in
box pews**

- Tagging (textual images) was the most prevalent form of graffiti represented as names and dates
- Majority informal
- Majority hidden to outsiders of the congregation
- Majority etched or engraved on wood
- Majority in box pews and steeple

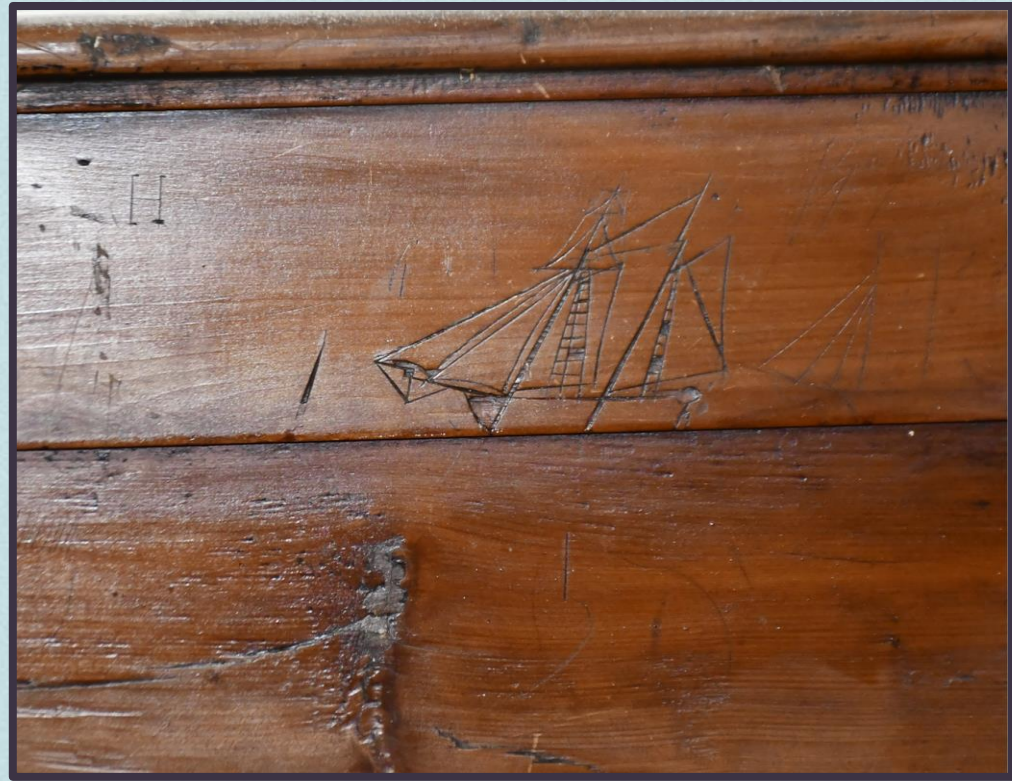
**Cross-section
view of ship
in box pew**

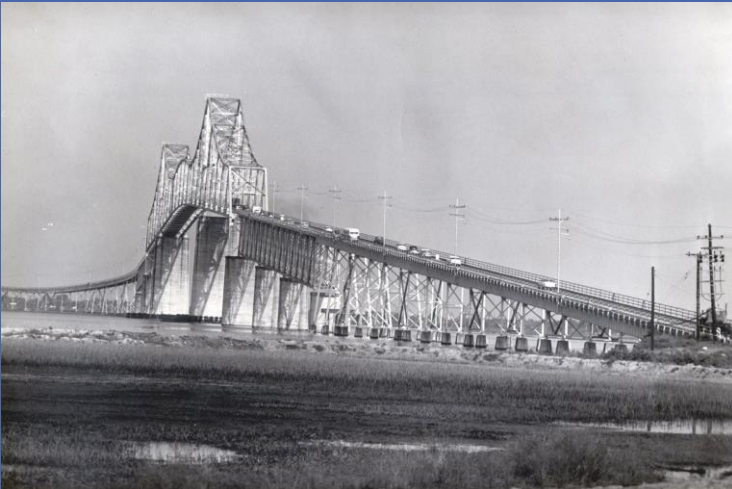
John P “Grace” Memorial Bridge, c. 1929

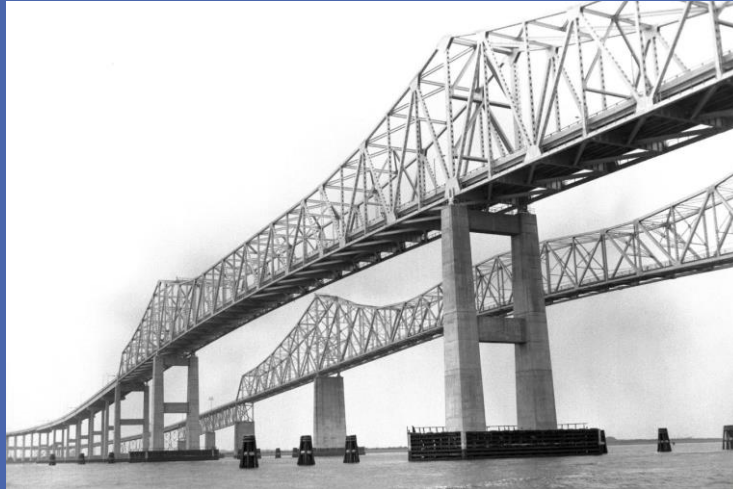
Silas N “Pearman” Bridge, c. 1966

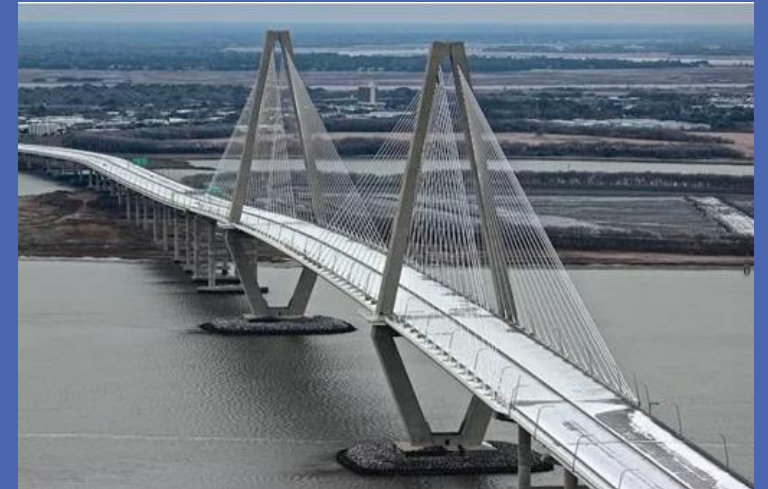
Arthur “Ravenel” Jr. Bridge, c. 2005

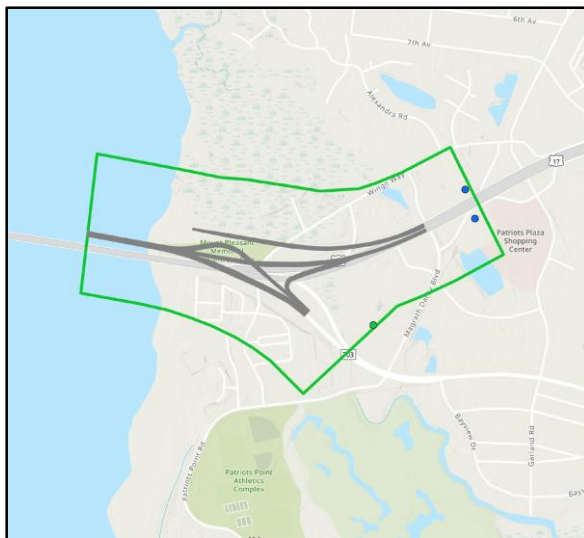
Pearman Bridge, Mount Pleasant study area

Distribution of Architectural Loss (Below)
