# Historic Preservation Work following Hurricanes and Lessons Applicable to All Disaster Recovery

Craig M. Bennett, Jr., PE, SE  
Bennett Preservation Engineering PC  
Charleston, South Carolina

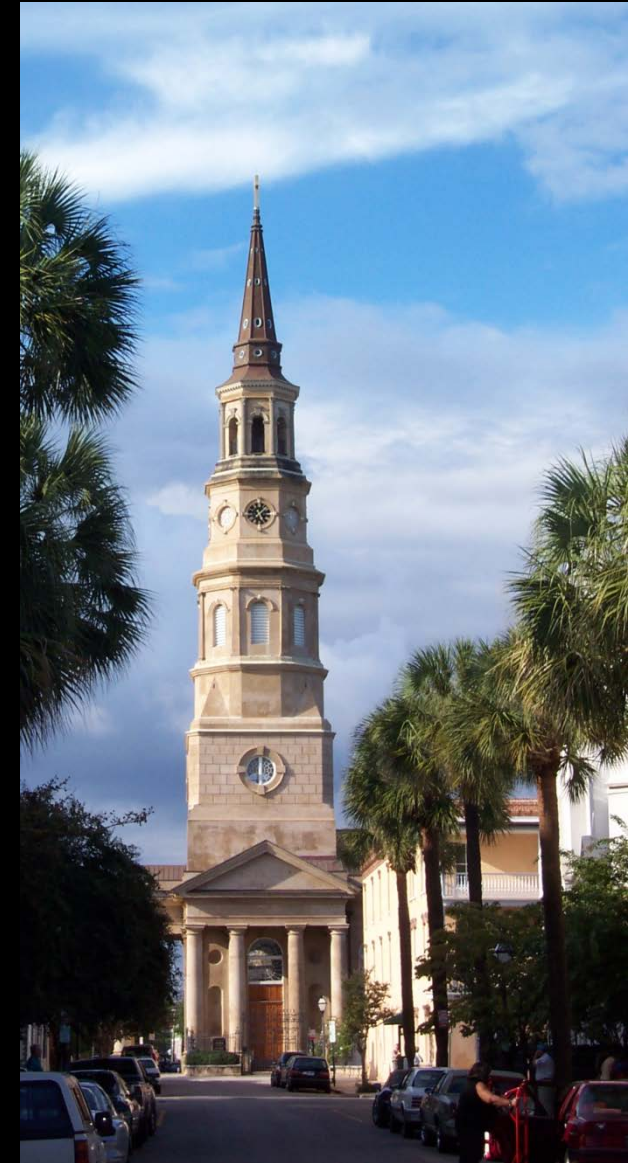
- Damage which becomes apparent later
  - Vibration – Stucco failures, structural damage

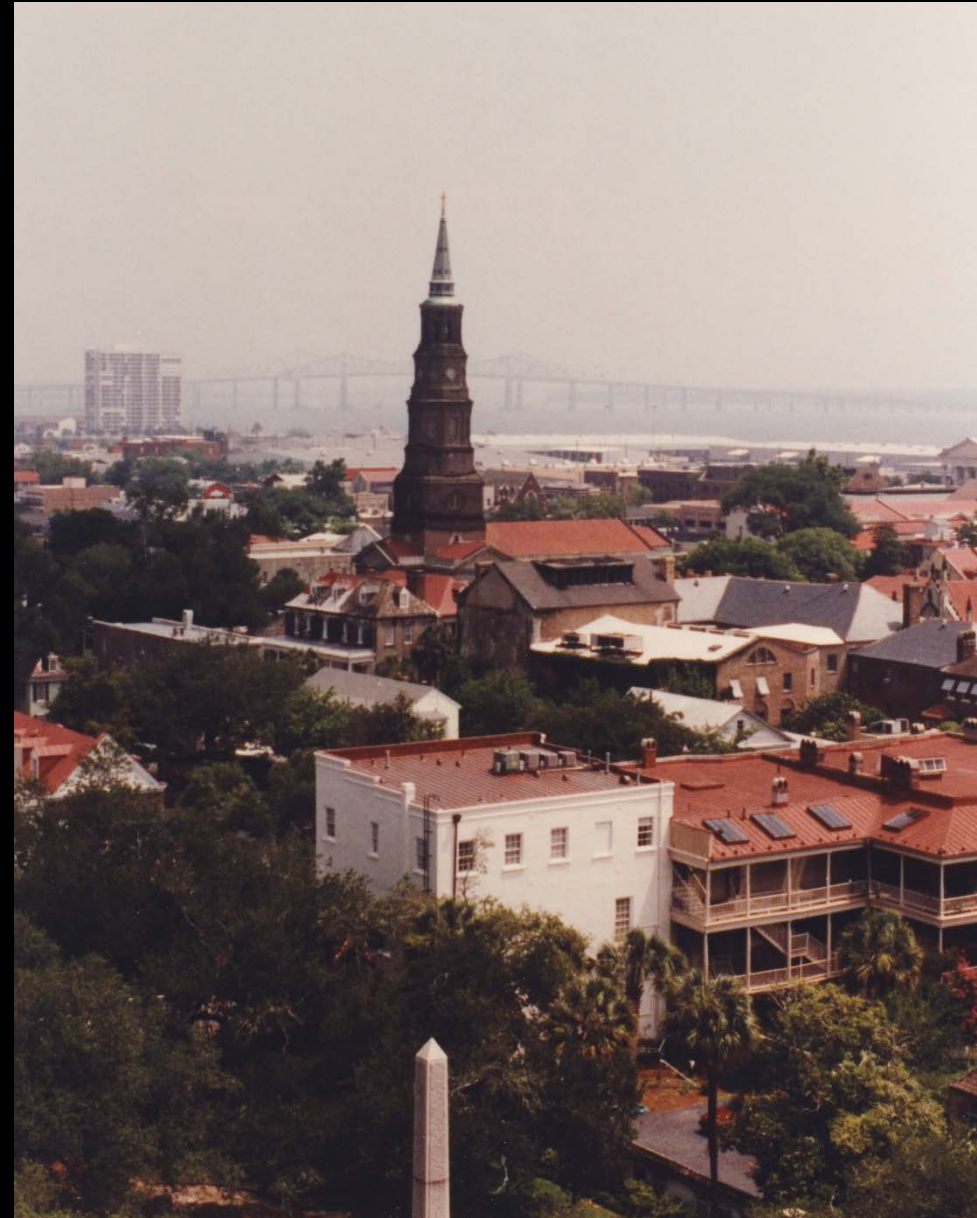
- Damage which becomes apparent later
  - 3 years after Hugo

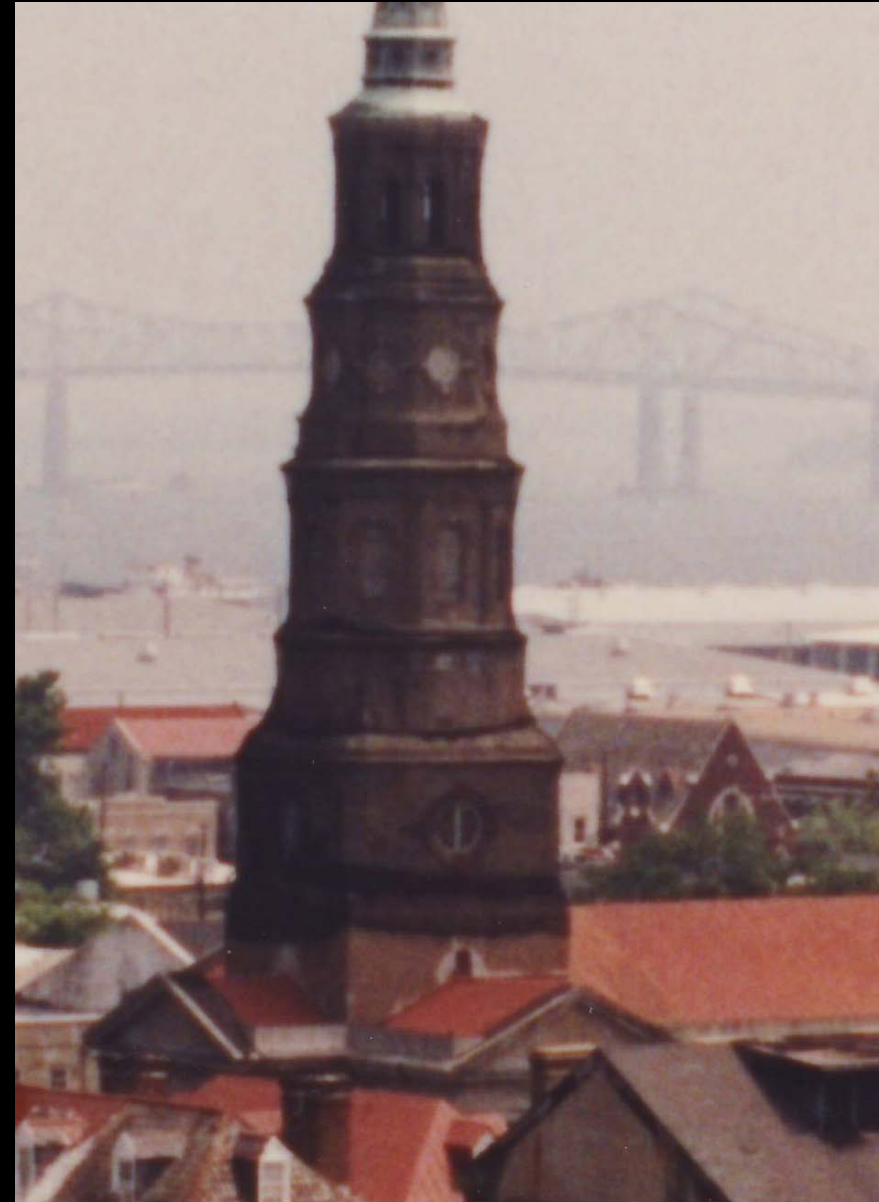
- Damage which becomes apparent later
  - 3 years later
  - Netting to catch stucco

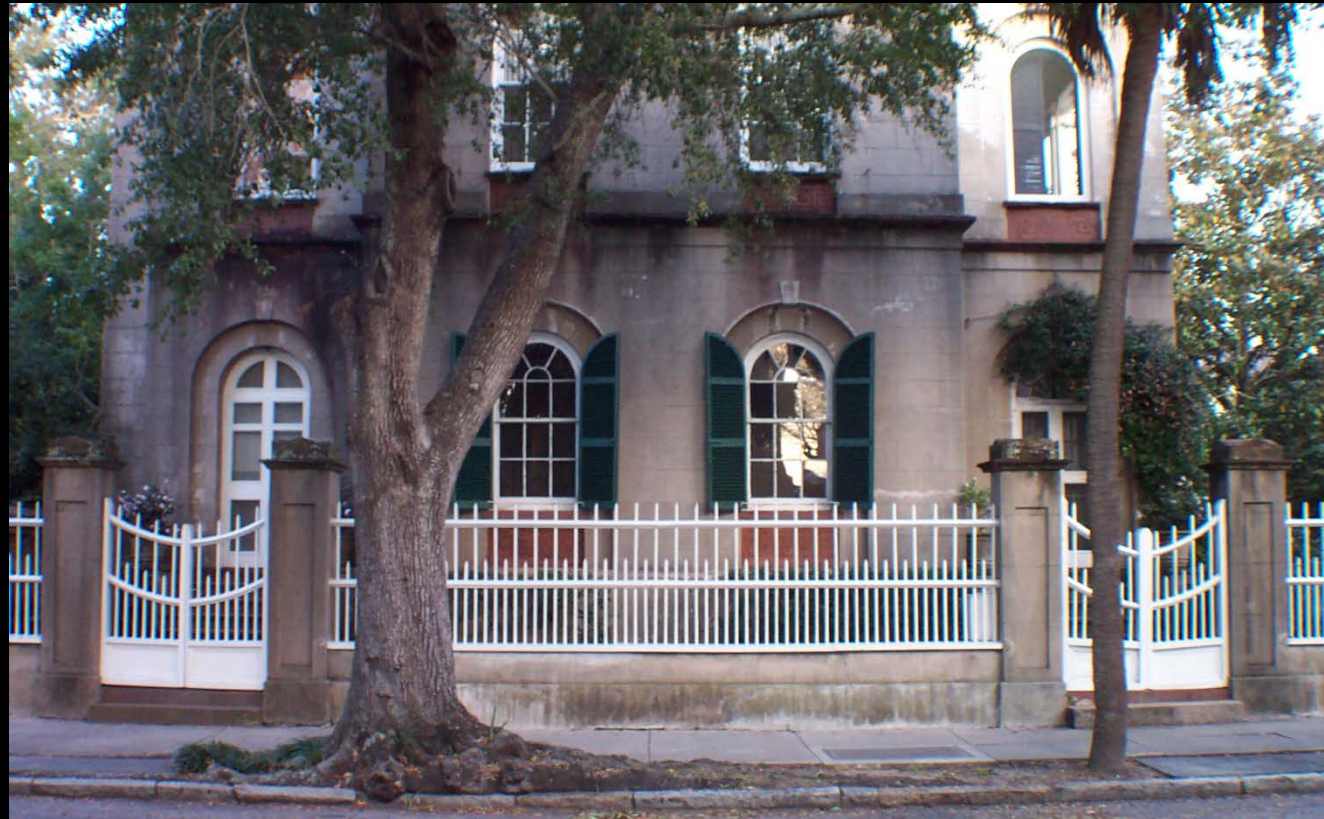
Vibration –  
Stucco  
failures,  
structural  
damage

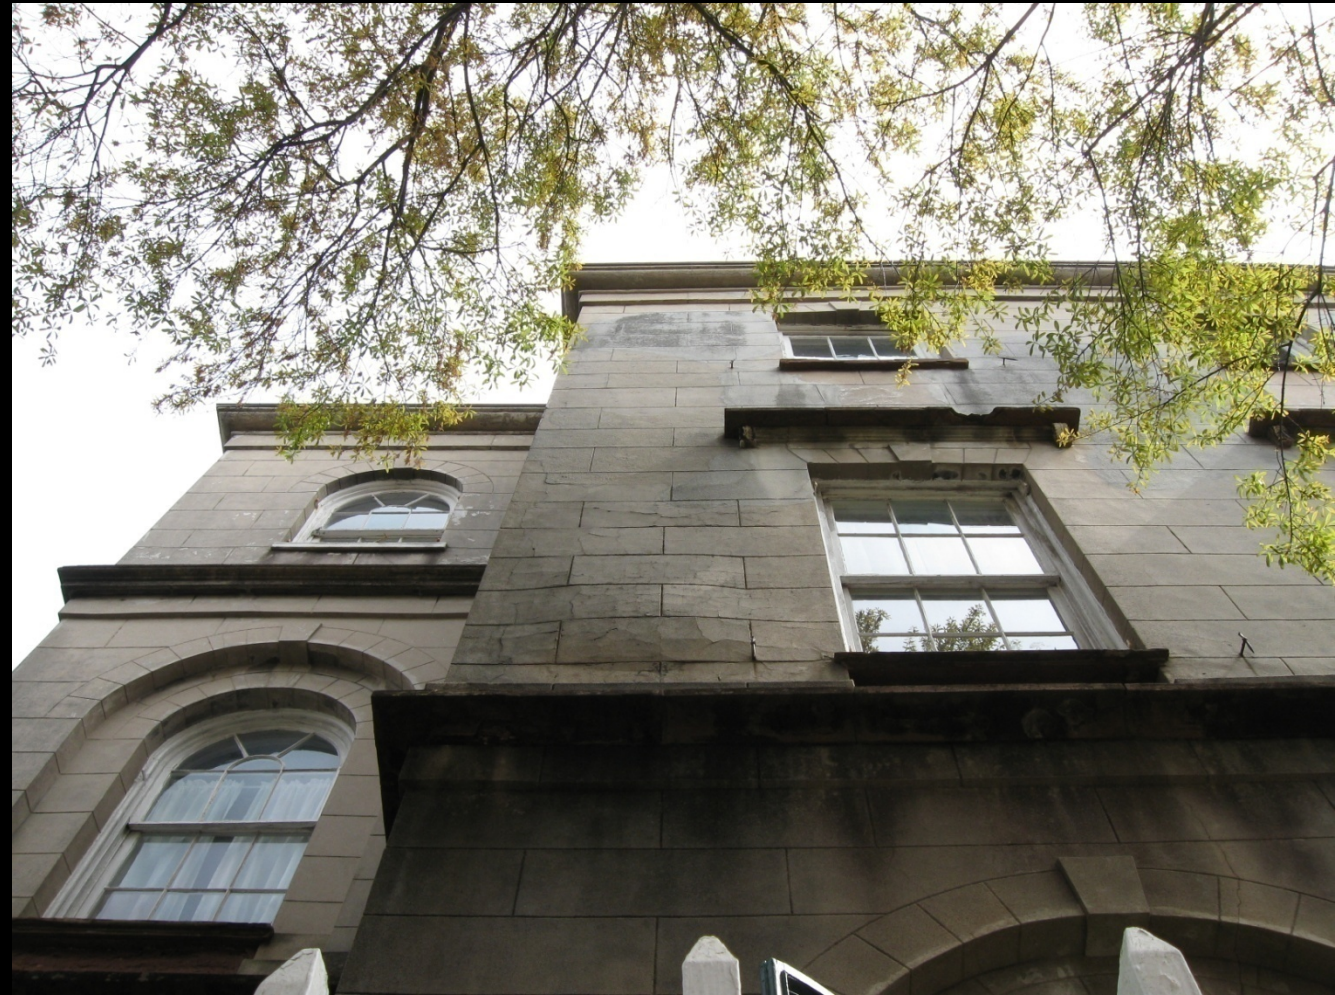
Damage  
becoming  
apparent  
10 years  
after Hugo

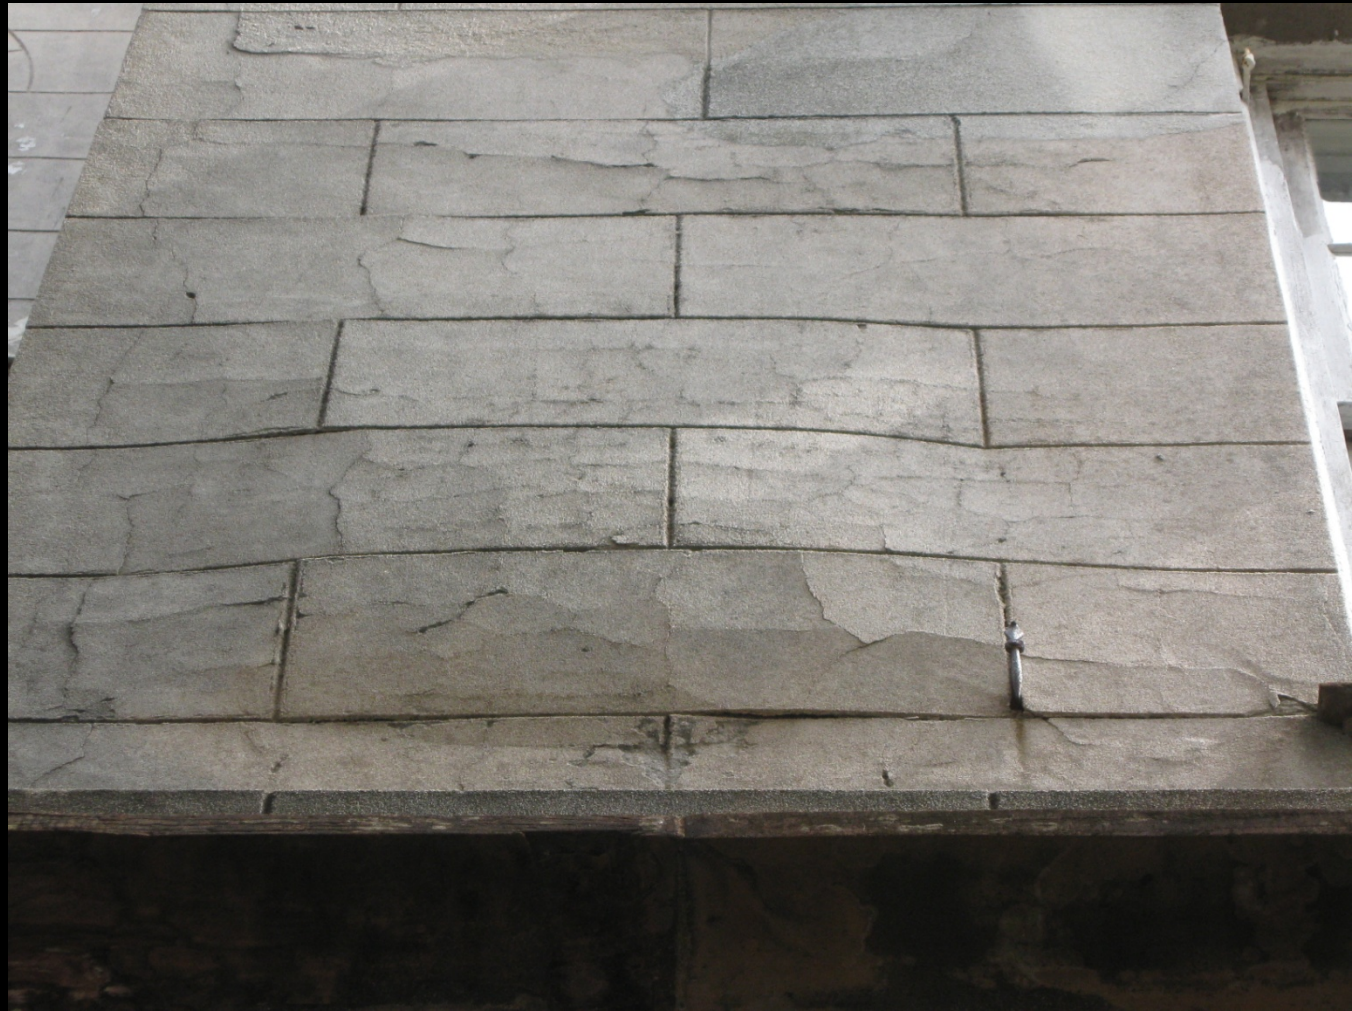
Vibration –  
Stucco  
failure

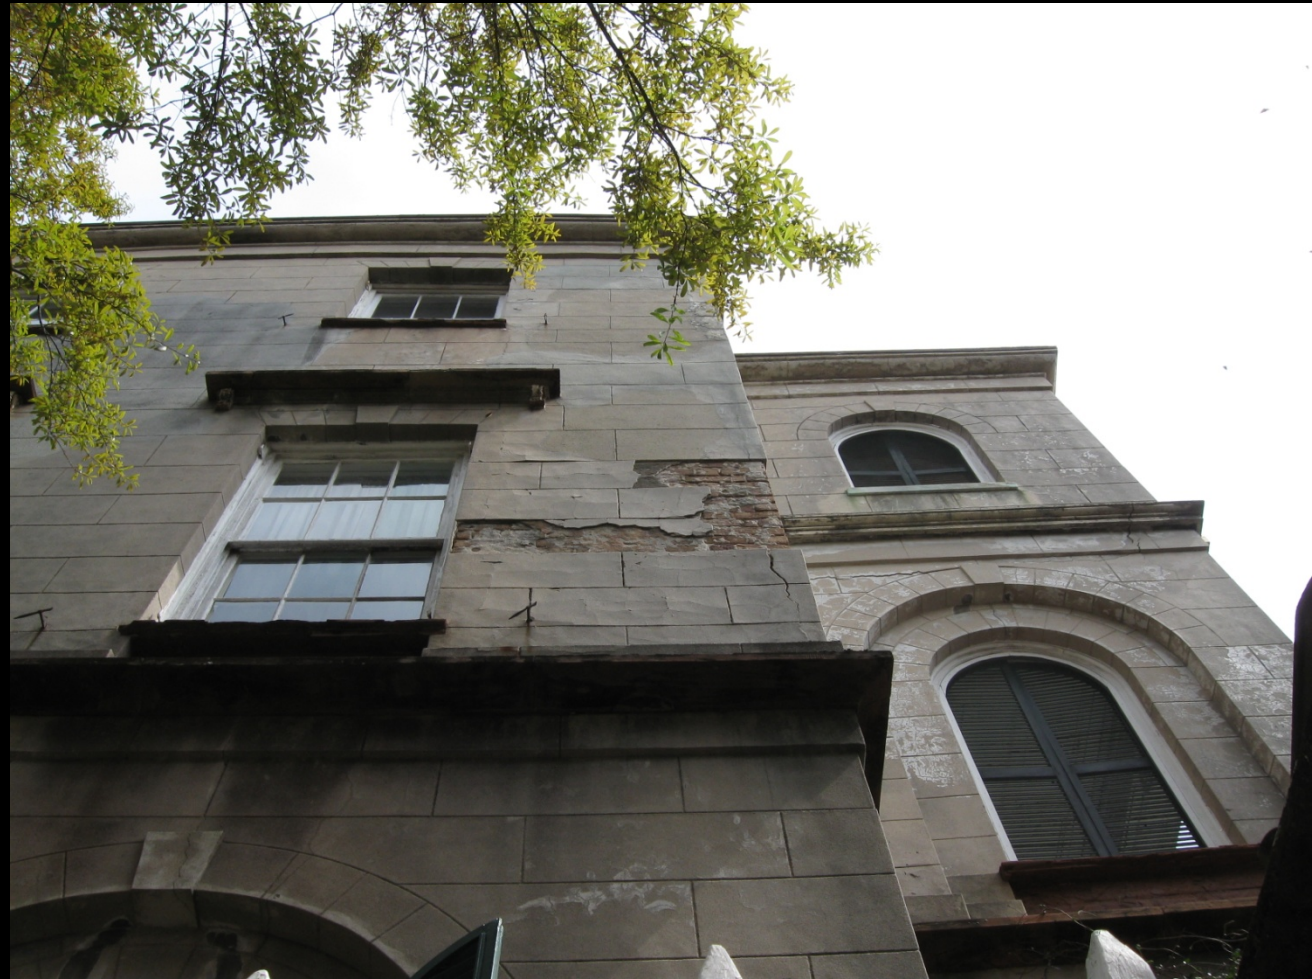
Vibration –  
Stucco  
failure

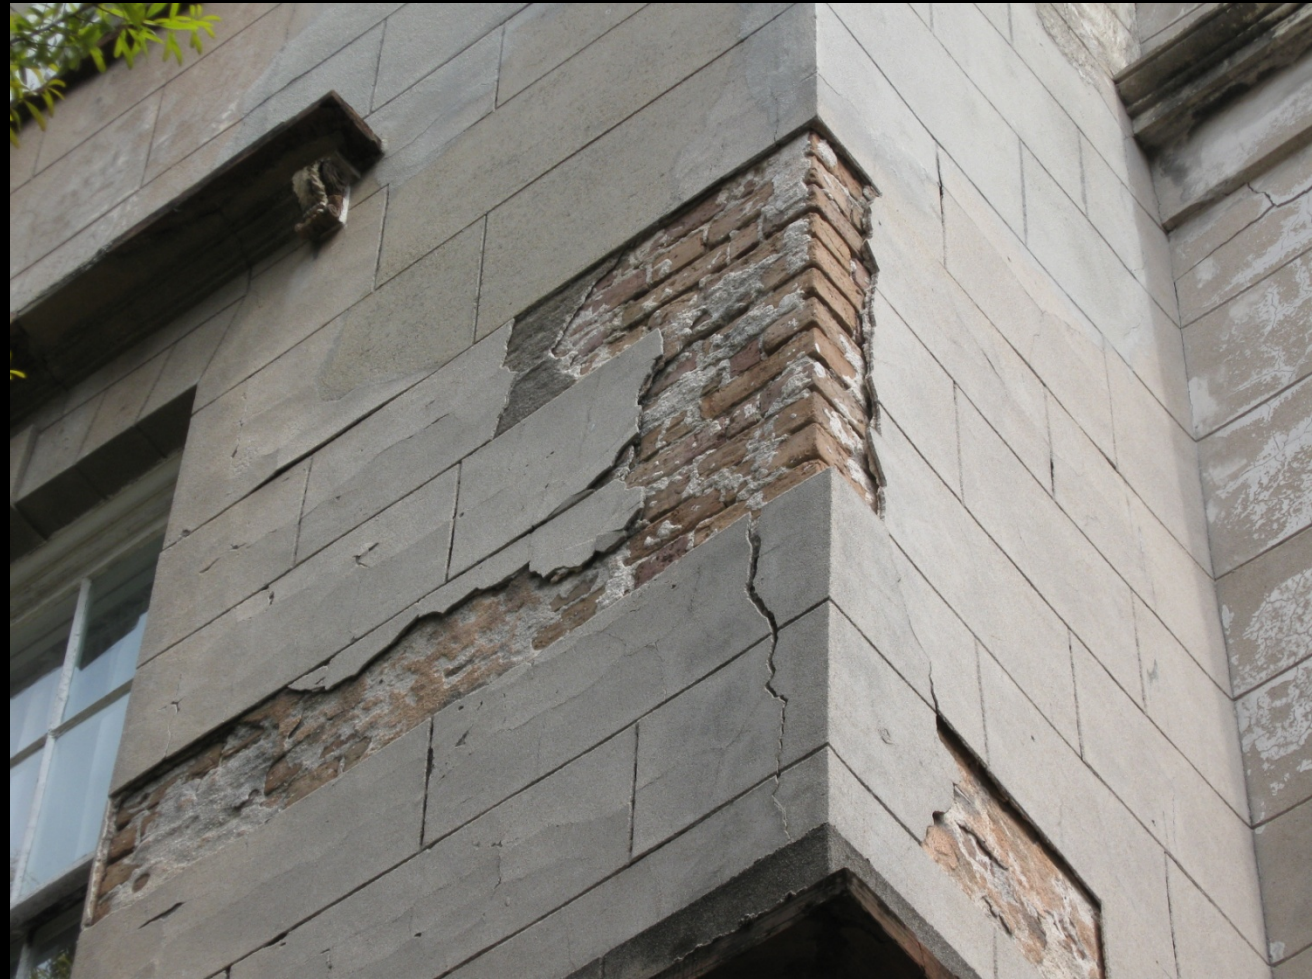
Major stucco  
loss 20  
years later

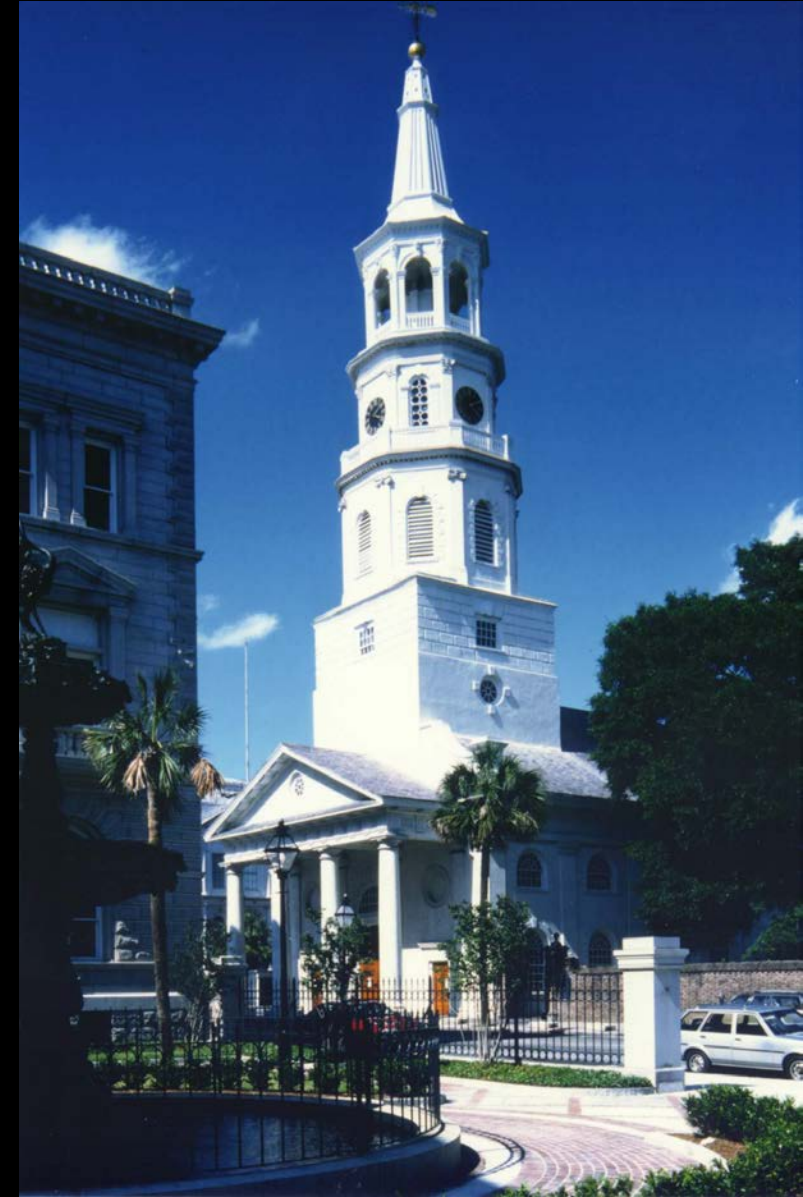
- Successful approach
  - St. Michael's Church
  - 1751, National Historic Landmark
  - Spire knocked out of position
  - Slate roof damaged
  - Significant interior plaster damage

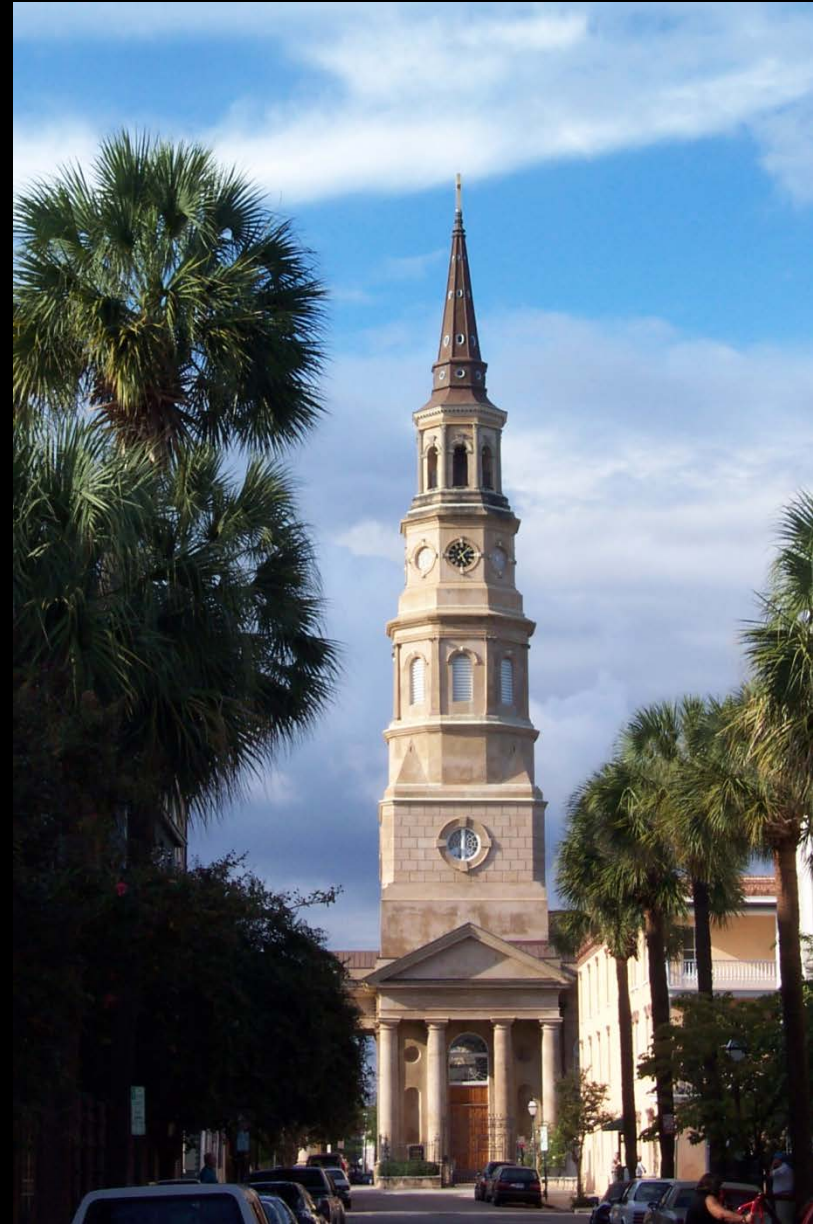
- Successful approach
  - St. Philip's Church
  - 1835, National Historic Landmark
  - Spire knocked out of position
  - Standing seam metal roof damaged
  - Significant interior plaster damage

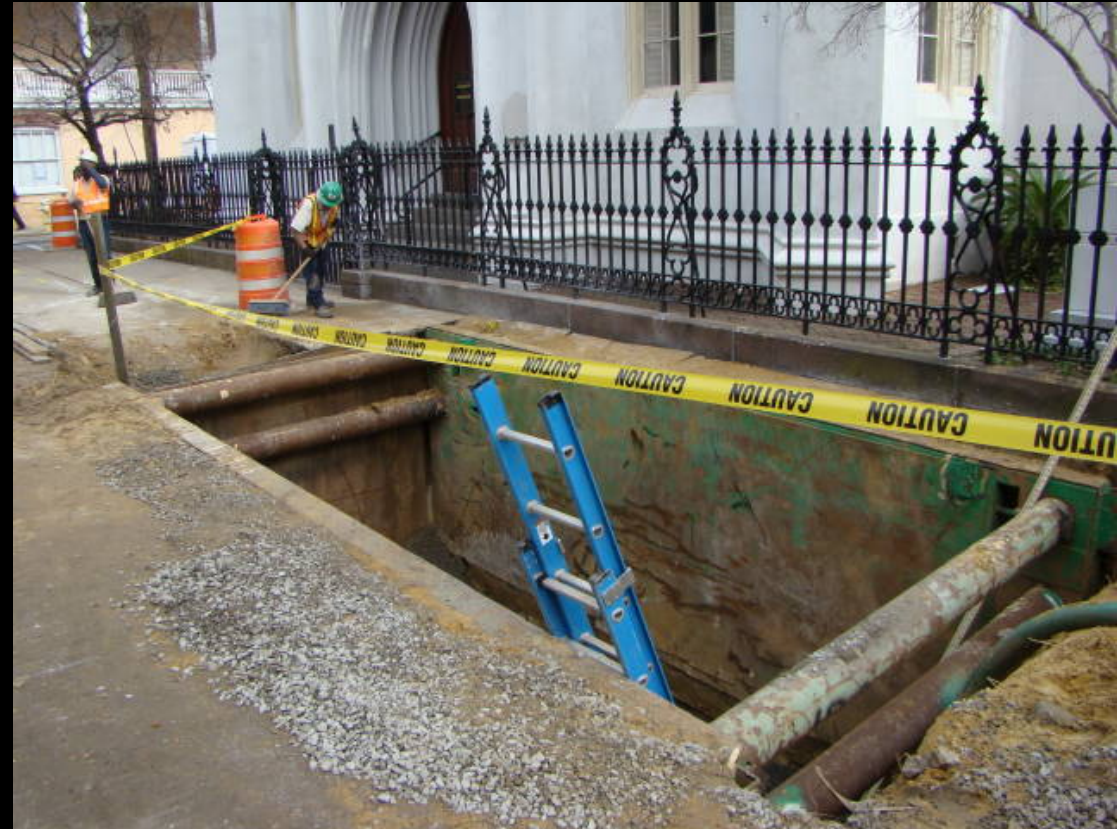
- Damage:
  - Installation of a trenchbox using a trackhoe
  - Severe vibration

- Immediate response: stop further damage
  - Don't let the trenchbox damage the foundation further
    - Don't extract the trenchbox!
    - Grout the loose soils around the box
    - Install grouted piles under the box
    - Fill the box, including the hollow side walls
    - Abandon the box in place

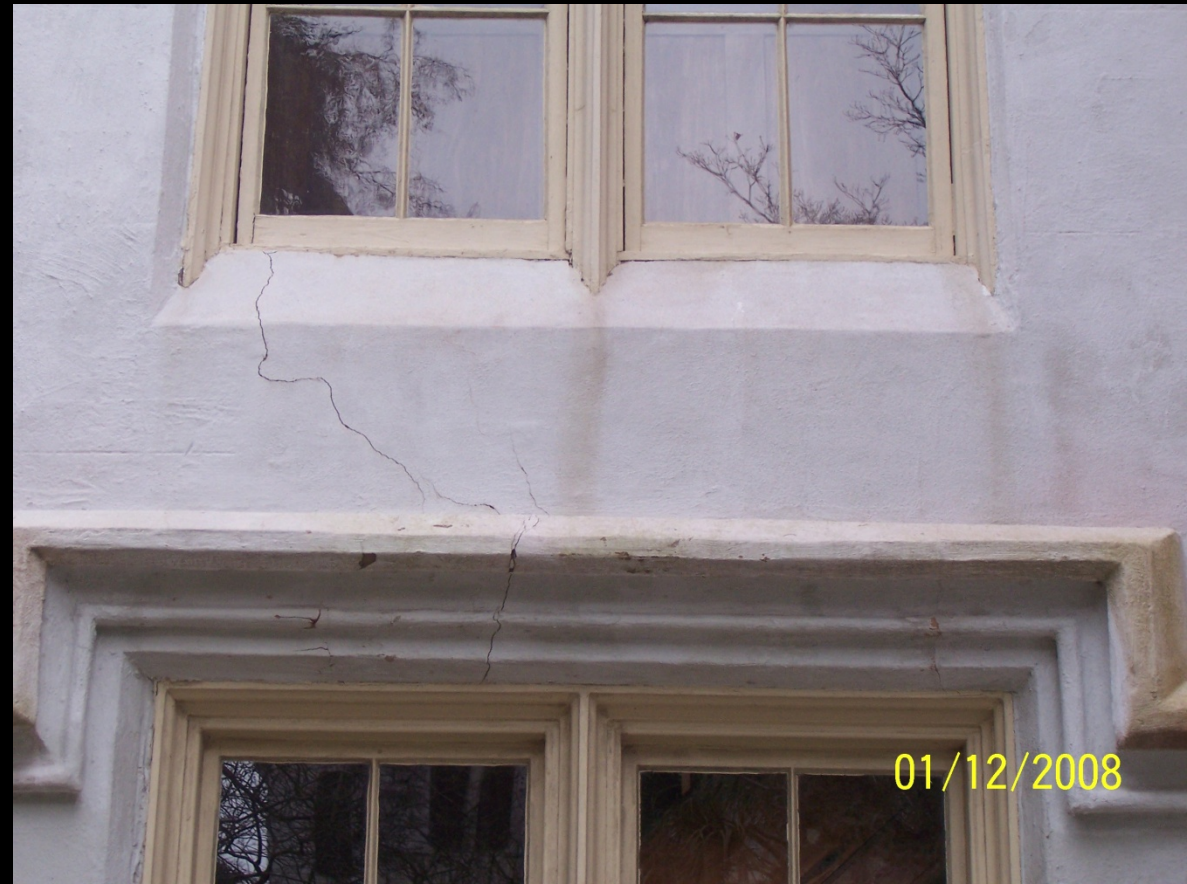
- Damage
  - Settlement of portions of building
  - Cracking of masonry, stucco and plaster

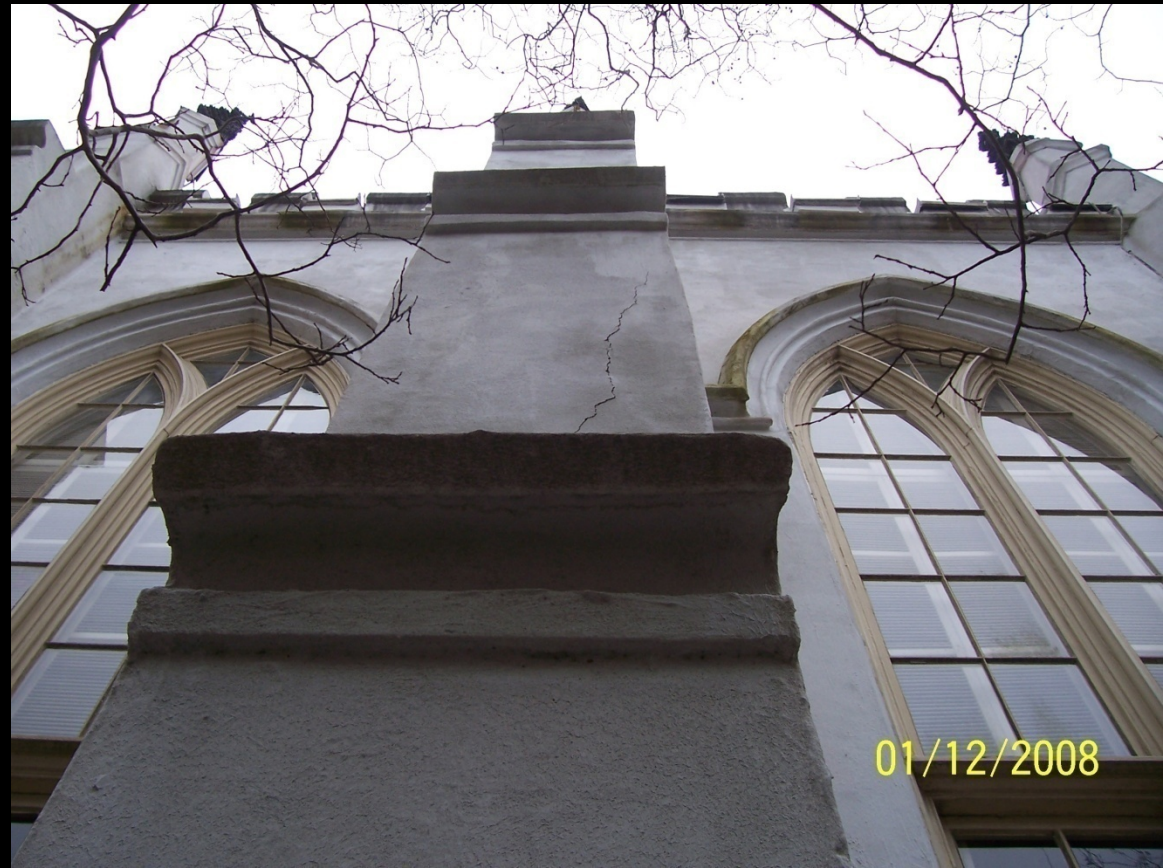
- Damage
  - Settlement of portions of building
  - Cracking of masonry, stucco and plaster

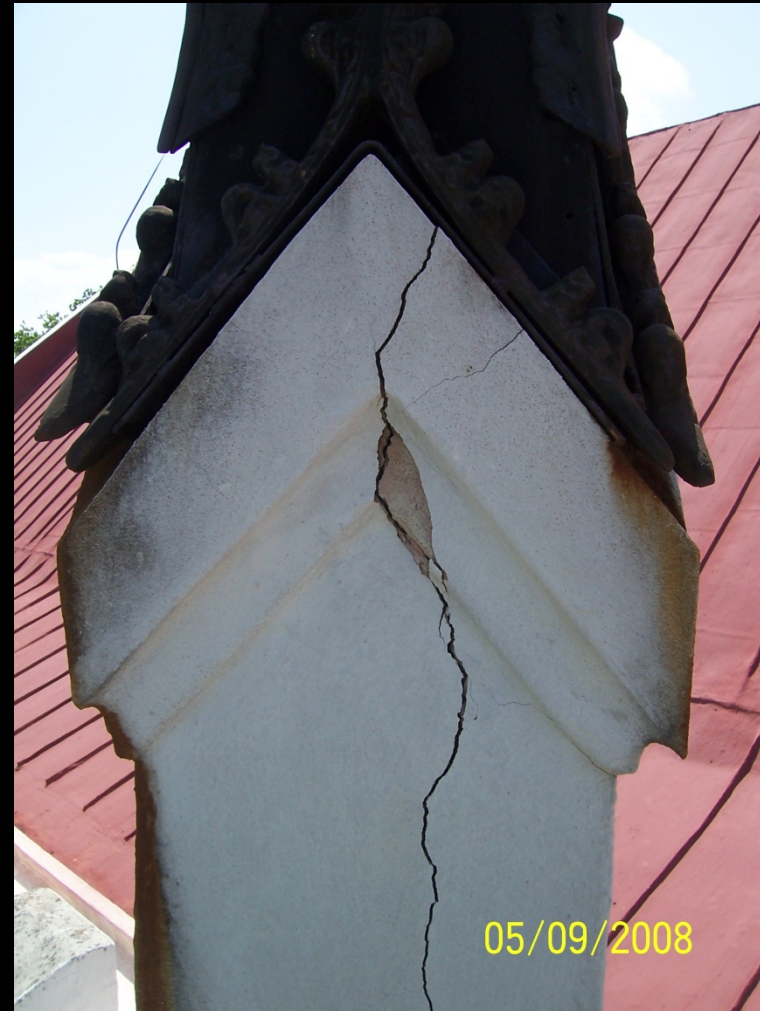
- Damage
  - Settlement of portions of building
  - Cracking of masonry, stucco and plaster

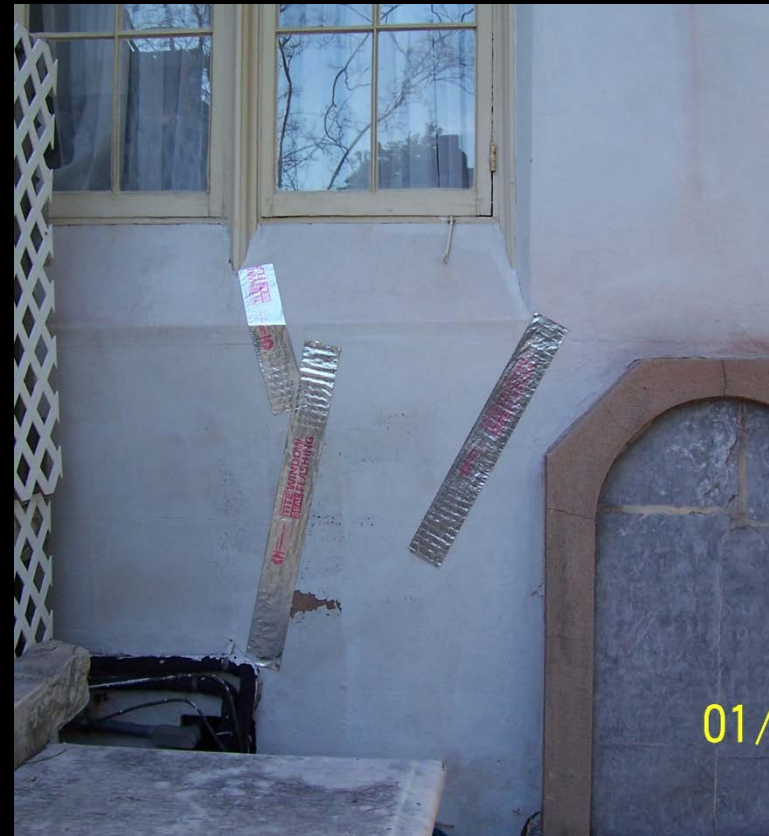
- Immediate response: stop further damage
  - Keep the water out of the building
    - Temporarily cover the cracks in the building skin

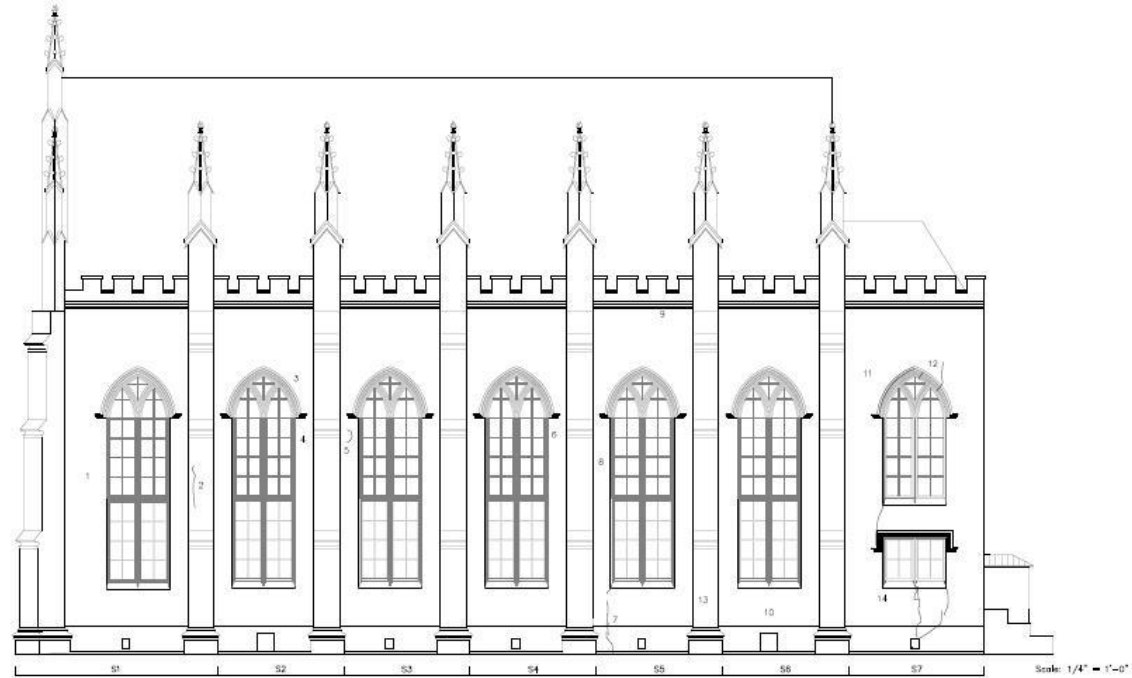
**South Elevation  
Preconstruction  
Conditions**

Notes and Commentary from Russell Rowley's Preconstruction Survey:  
 1, S1: Cemetery - looking at south wall. Some minor paint defects in the stucco at the south wall.  
 2, S2: First buttress has crack in stucco.  
 3, S3: Peeling paint over exposed window set on surface and adjacent wood.  
 4, S4: Significant deterioration between stucco and wood.  
 5, S5: Third window set - peeling paint from stucco surface behind paint.  
 6, S6: Fourth window set - peeling paint both on stucco and wood. Separation is occurring between the materials.  
 7, S7: Fifth window set - There are visible cracks in the Preconstruction Survey recording, located below the window.  
 8, S8: Paint failure on wall adjacent to window.  
 9, S9: Piece of reinforcing steel at cornice work is rusted and spalling.

10, S10: Sixth window set was skipped during Preconstruction Survey.  
 11, S11: Southwest corner - Surfaces have some light staining and small paint failure.  
 12, S12: There is cracking here that continues down through top edge of window (not visible inside).  
 13, S13: Paint failure on adjacent buttress.  
 14, S14: Cracking all through this area.

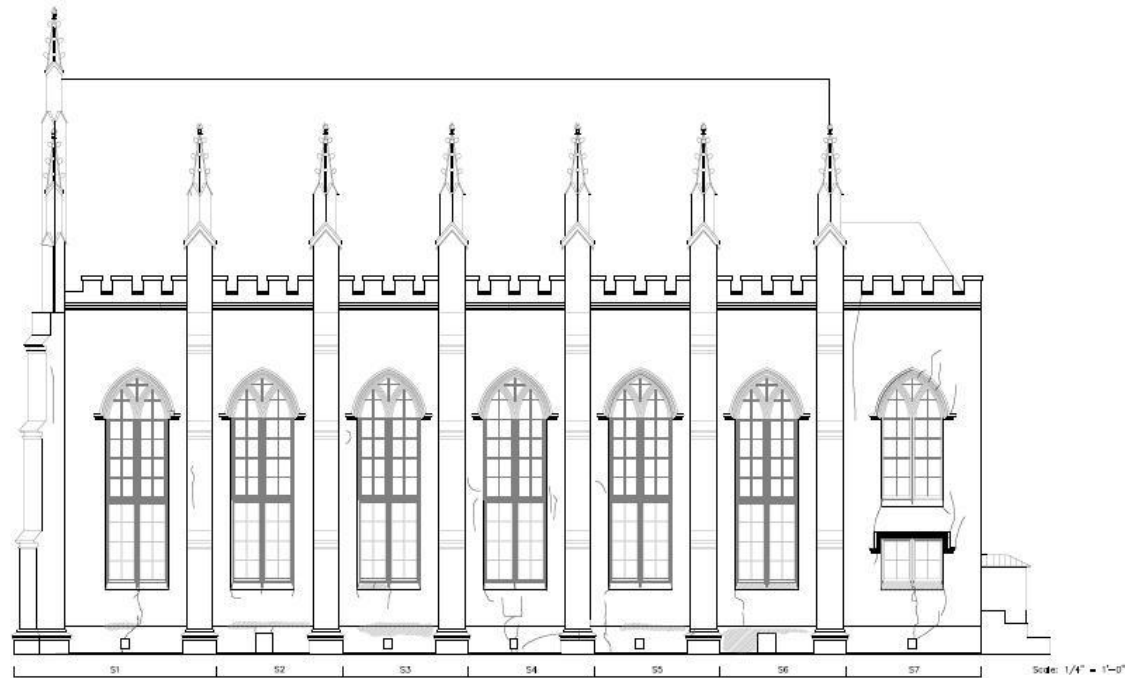
**South Elevation Existing Conditions**

**Notes:**  
 S1: The crack in the buttress to the west of S1 was documented in the Preconstruction Survey, but has probably worsened since that time. A new crack is present in the buttress to the west of S1. Several new cracks are evident below the window, as well as on the pilasters on the buttress to the east.  
 S2: Cracks were found below the window and on the southeastern face of the pilaster were not noted in the Preconstruction Survey.  
 S3: Stucco loss and missing paint located along the molding detail above the window were documented in the Preconstruction Survey. Newly observed conditions include cracking below the window, spalling below the window, and network cracking along the top of the water table.  
 S4: Missing paint and stucco loss along the molding detail above the window are consistent with the observations of the Preconstruction Survey. New cracks are seen to the right of the window.

S5: Cracks extending from the bottom of the window through the water table were recorded by the Preconstruction Survey, but the network cracking in that area and the crack to the west of the window were not observed until January of 2009.  
 S6: The top window sill was damaged during the Preconstruction Survey. There is currently a crack below the window and network cracking around the water table.  
 S7: This area is in worse condition than the other bays of this elevation. During the Preconstruction Survey, the surfaces along the lighting rail were exhibiting spalling. The current conditions are consistent with those observations, but there is now a crack running along the side of the lighting rail that extends up through the cornice to the top of the parapet. Cracking in the molding above the pointed arch window, between the two windows, and below the bottom window and deformation of the head of the bottom window have all worsened since the Preconstruction Survey.
