# DOVEDALE HOUSE

## Historic Preservation Plan

Darlington County, South Carolina

May 7, 2012 • Final Report  
New South Associates Technical Report 4091

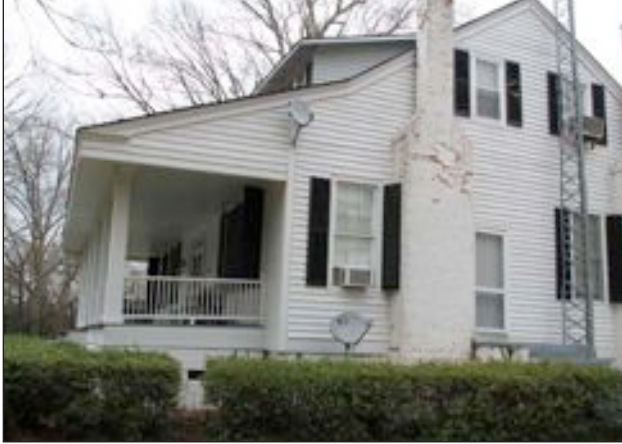
A. View Northeast

The 53-foot façade is dominated by the almost full-width porch, which measures 44.5x9.5 feet and features six slightly battered, solid wood square columns (Figure 3A). Supporting a porch roof with a generous overhang, the columns may have supplanted older columns that were placed in the ground to reach the edge of the porch roof, creating a “Carolina” or “rain” porch, although the current owners do not remember such a feature (Figure 3B). Such placement of the columns in the ground supported a roof that extended a few feet from the front edge of the porch floor, and offered some protection from the elements. The porch floor also slopes, a traditional feature that helped with water elimination. Porch banisters are simple wood pickets (Figures 3C and 3D).

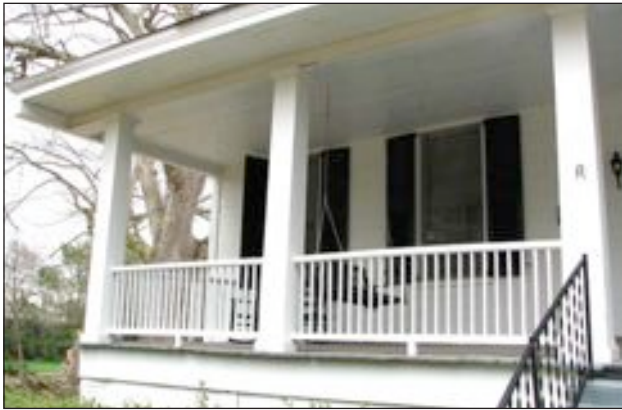
B. View East, Note Wide Overhang

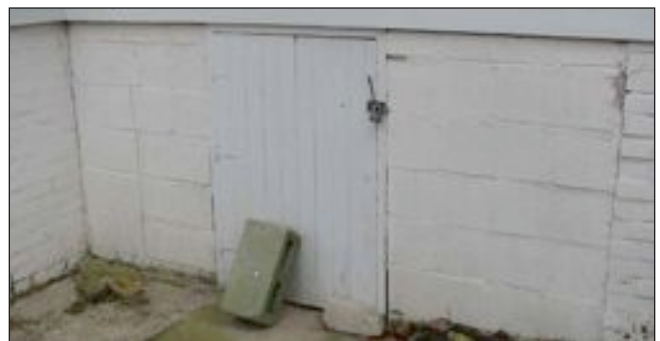
D. Concrete Block Foundation Infill and Crawlspace Door, Northeast Porch End

The southwest side of the house is asymmetrical, with several single windows and a single door leading to the southwest room (Figures 2B and 5A). Large exterior chimneys resting on massive foundations dominate both the northeast and southwest sides. Though originally, all four of the chimney foundations were constructed of brick, one of the northeast side chimneys was badly damaged and rebuilt with a concrete foundation in the twentieth century (Figures 5B and 5C). The former pine piers under the house were replaced in 1961 with concrete block piers, while it appears the exterior brick piers remained (McLaughlin 2006:5). The open foundation was enclosed in 1961 with concrete block around the porch and southwest side of the home (Figure 5D), and with brick around the rest of the home (Figure 5E). Concrete stairs were added to the front and rear entrances that same year (Figure 4E).

The biggest culprit in historic home deterioration is moisture. This damage often occurs from exposure to regular rainfall, but groundwater underneath a house is also potentially damaging. The Dovedale house historically had an open foundation of approximately four feet in height. When enclosed around 1961, very few vents were installed in the new masonry curtain around the base of the house. In fact, there are no vents on the northwest side and there do not appear to be any vents on the northeast and southeast sides. There are a few small vents on the southwest side (Figure 2B). Proper ventilation below the building will help with water evaporation and will reduce moisture, which can damage the wood floor joists and other wood supports over time. Likewise, there is no ventilation to the roof. The next time the roof material is replaced, an unobtrusive ridge vent should be installed.

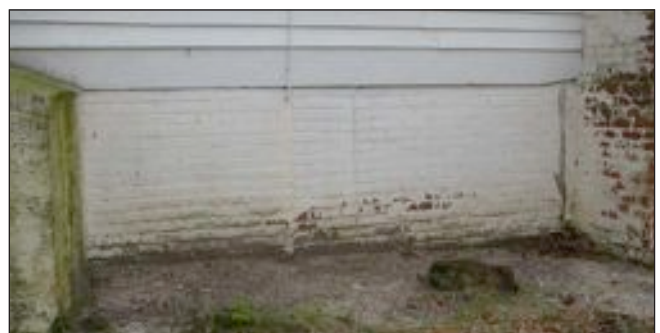
E. Brick Infill and Brick Pier Foundation, Northeast Porch End

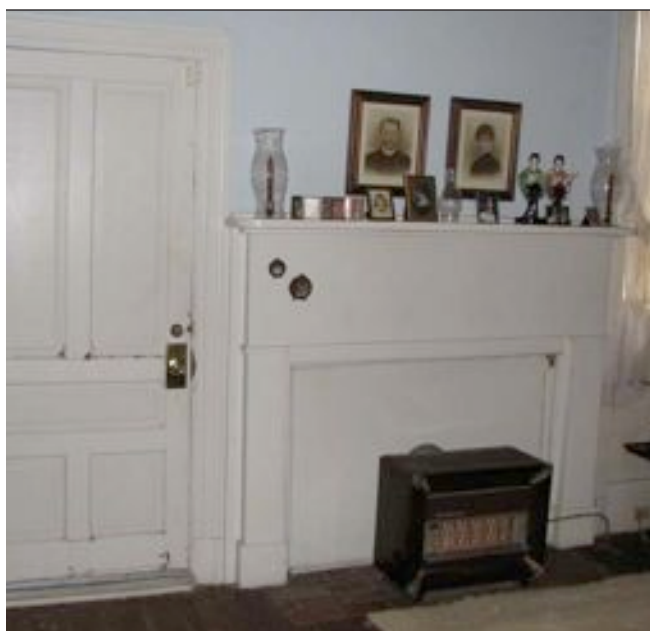
Features of the main massing include plaster walls in the four central rooms (two bedrooms, parlor, and dining room) (Figure 8A) and a fireplace in each room. Only one such fireplace appears to be in working order (Figure 8B), while all others have been closed in (Figure 8C). The current owner's assumption that the rear bedroom used to be the dining room is supported by the presence of a small "jelly closet" behind the bed in this room (Figure 8D). The ceilings in the main massing of the building are 12 feet high.

C. Front Bedroom Fireplace, Southwest Wall

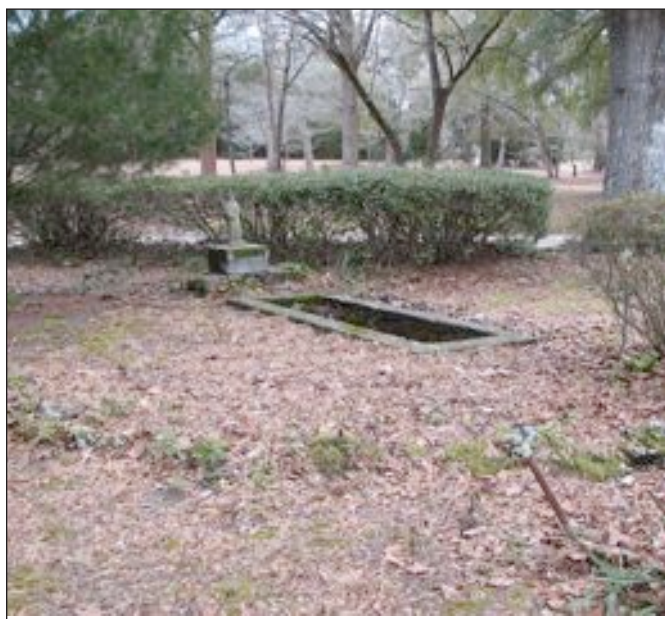
A. Goldfish Pond, Constructed 1930s

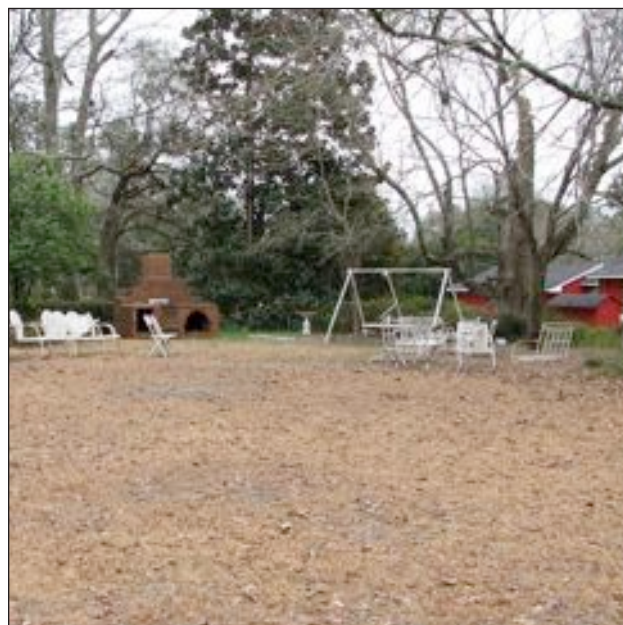
B. Barbeque Pit and Lawn Chairs, View South

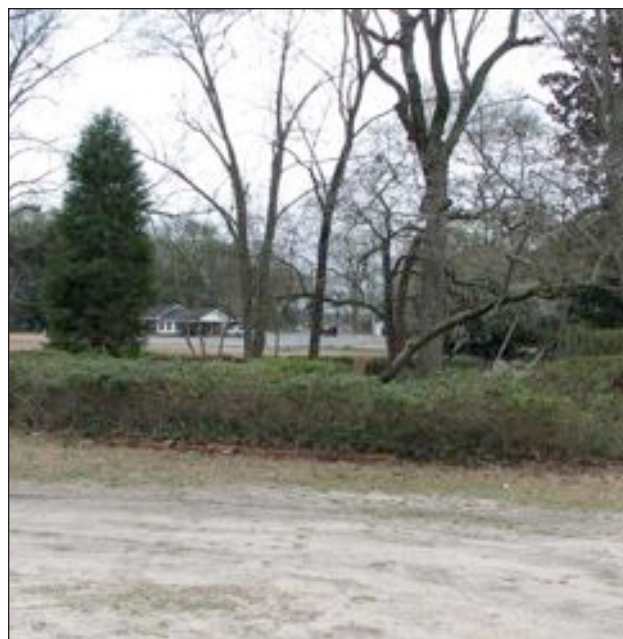
D. Arranged Shrubberty and Formal Plantings to Rear of House, View South

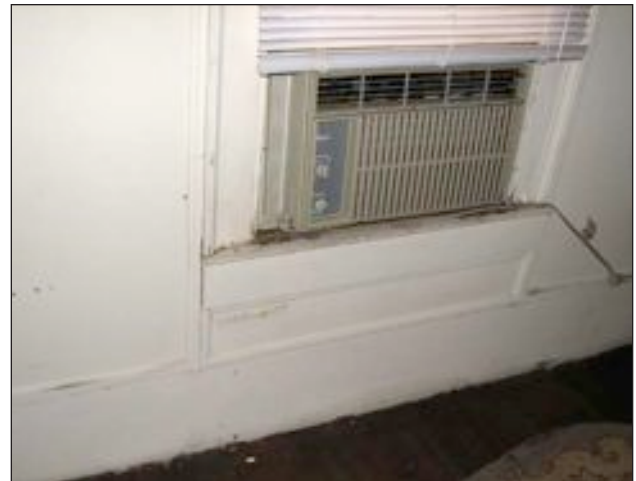
Windows throughout the house need regular maintenance. Water damage is evident in joints and sills throughout the house, particularly when accompanied by a window air conditioning unit (Figures 16A and 16B). While other factors can cause window damage, moisture is the most common cause for historic wood window failure. Windows should be closely examined for paint failure. Paint failure—blistering, cracking,

A. Second Story, North Bedroom, Window Along Northeast Wall

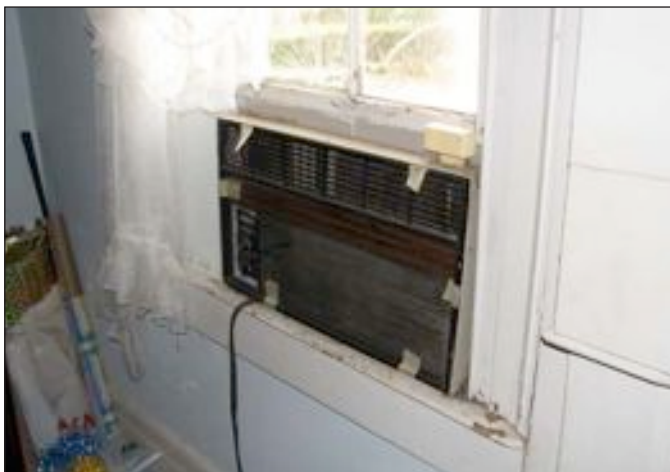
B. First Floor, Rear Bedroom, One of Two Windows Flanking Fireplace Along Southwest Wall
